Business/Economic Analysis for the Proposed Green Branch Multi-Field Sports Complex in Prince George's County, Maryland

Final Report January 2014

Conceptual Design Study Green Branch Multi-Field Sports Complex Prince George's County

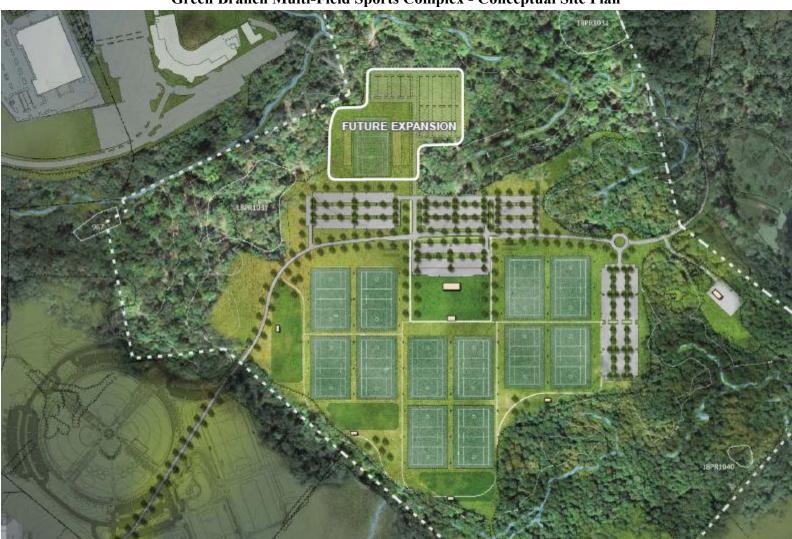
Green Branch Multi-Field Sports Complex - Conceptual Site Plan

Based on the above program elements at this site location, the MSA, in conjunction with its design advisors (Hord Coplan Macht), pre-construction management advisors (Barton Malow) and other project team members, estimated the preliminary total project costs for the proposed new Green Branch Multi-Field Sports Complex to be approximately \$46.8 million. A more detailed analysis related to the preliminary project cost estimate can be found under separate cover in Barton Marlow's report entitled the *Green Branch Multi-Field Sports Complex – Concept Estimate, Final* dated January 22, 2014.

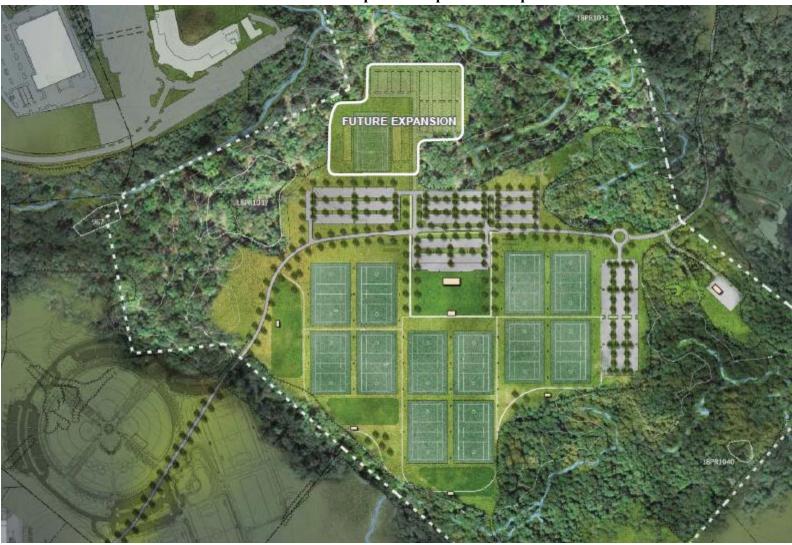
Green Branch Multi-Field Sports Complex - Conceptual Site Plan

As shown in the following conceptual site plan prepared by Hord Coplan Macht, the Green Branch Park site can adequately accommodate all of the recommended programmatic elements in a manner that maximizes its marketability to youth/amateur tournament activity. Although the majority of event promoters indicated that a championship field could enhance the complex's marketability and competitiveness for hosting certain competitions/tournaments, it was viewed as a complementary enhancement not a necessity. Having said that, most event promoters stated they would likely utilize all available field space for large-scale tournaments. From a long-term planning perspective, the size and layout of the Green Branch site can support the recommended core program in the short-term and allows for expansion of program elements in the future (e.g., championship field) based on market demand.

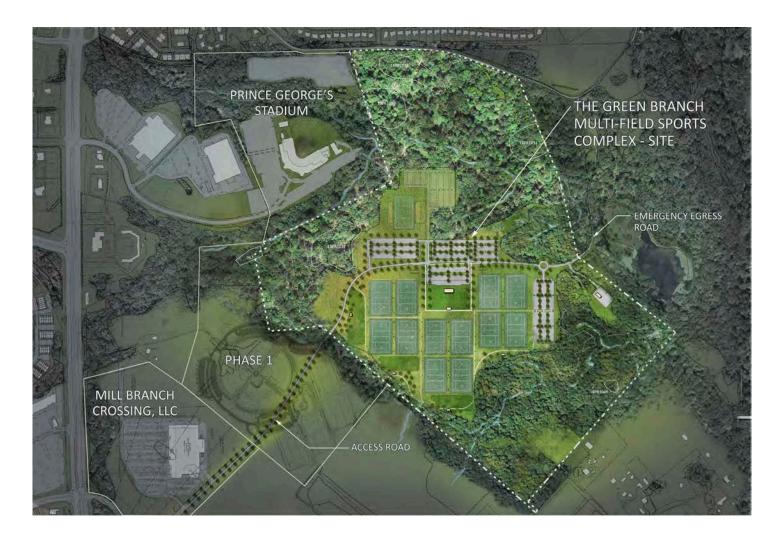
Site Access

A secondary access point is located off of Governor's Bridge Road, utilizing the existing WSSC "haul road" which accesses the Green Branch site from the east. This access point is not suitable as a main entrance, however it is planned as an emergency access route.

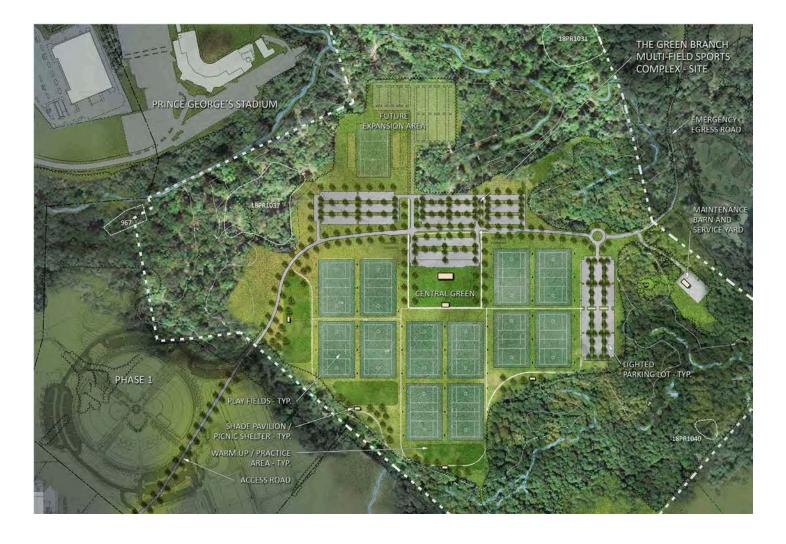
The main site access point is from the south through the Mill Branch Crossing, LLC property at US 301 and Mill Branch Road. At this location there is a 50-foot easement to provide access from Mill Branch Road through the Phase 1 M-NCPPC park site and onto the Phase 2 Green Branch Athletic Facility site.

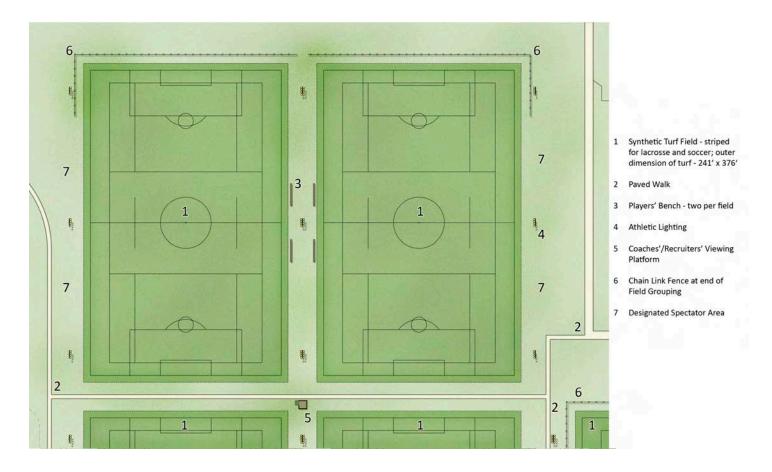
The athletic field surface is planned to be synthetic turf. Field size and turf areas are based on accommodating lacrosse, soccer, field hockey and ultimate Frisbee events. Soccer is the largest field requirement; therefore the turf dimensions are sized to accommodate soccer with ample space to provide for "over-run" space for the players. It is anticipated that the fields will be painted (lined) for soccer and lacrosse only. Placement of fields and field spacing is also based on our team's review of case study precedents provided by Crossroads Consulting.

Each group of four fields contains separated areas for player benches, spectator viewing and a central coaches viewing platform for coaches to view games from the center of each grouping of four fields. This would enable a coach to view four games and multiple players at once.

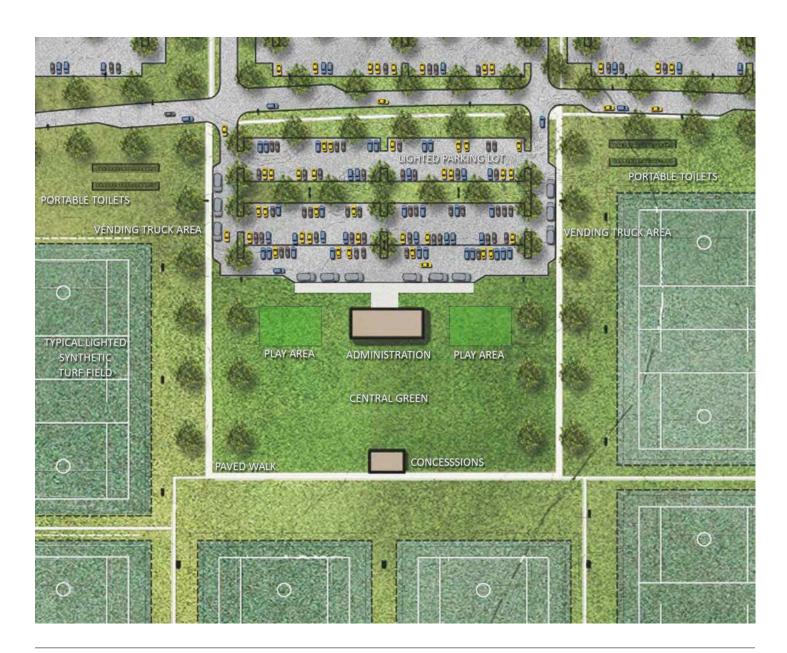
Warm up / Practice Areas and Picnic Areas

On either side of the central administration building, are two children's play areas that are far enough away from the playing fields and parking lots to be safe, but close enough to provide convenient access for parent supervision during tournament activities.

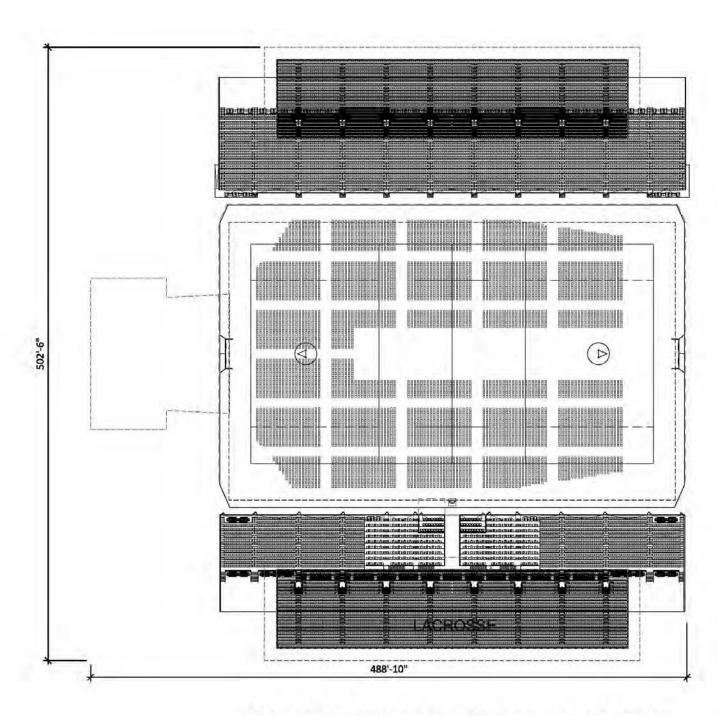
14,178-SEAT PROFESSIONAL LACROSSE STADIUM CONCEPT PLAN BY 360 ARCHITECTURE

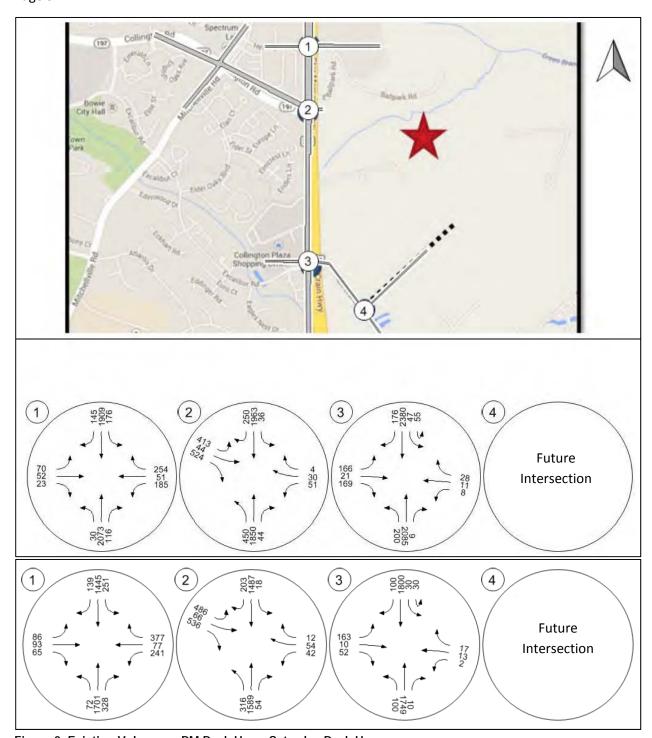
Figure 3. Existing Volumes – PM Peak Hour, Saturday Peak Hour

Figure 3 shows the existing volumes for the study intersections.

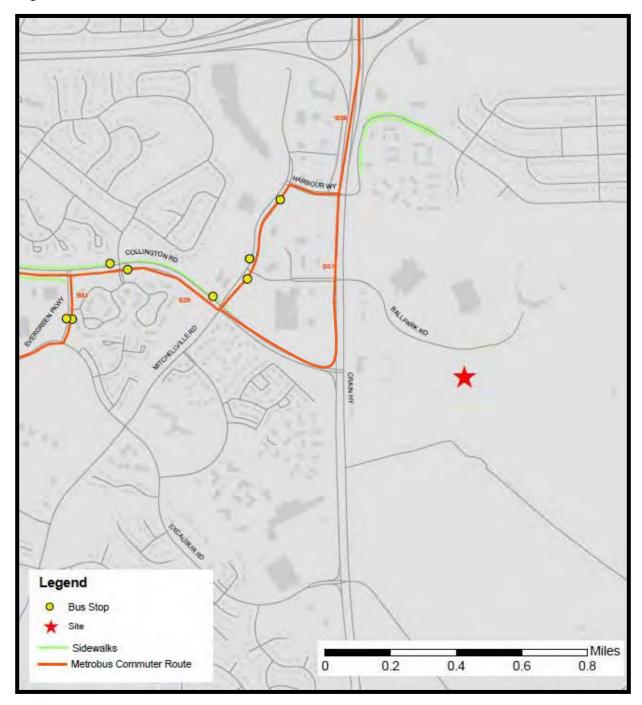
Figure 5. Existing Transit Network

Two WMATA Metrobus commuter routes (B29 and B31) serve the study area, as shown in Figure 4. The buses operate on a Monday through Friday schedule for approximately two hours in the mornings and six hours in the evenings. There is no weekend bus service. Sidewalk is not present at any of the study intersections nor are there designated bicycle facilities in the study area. **Figure 5** illustrates the transit network within the study area.

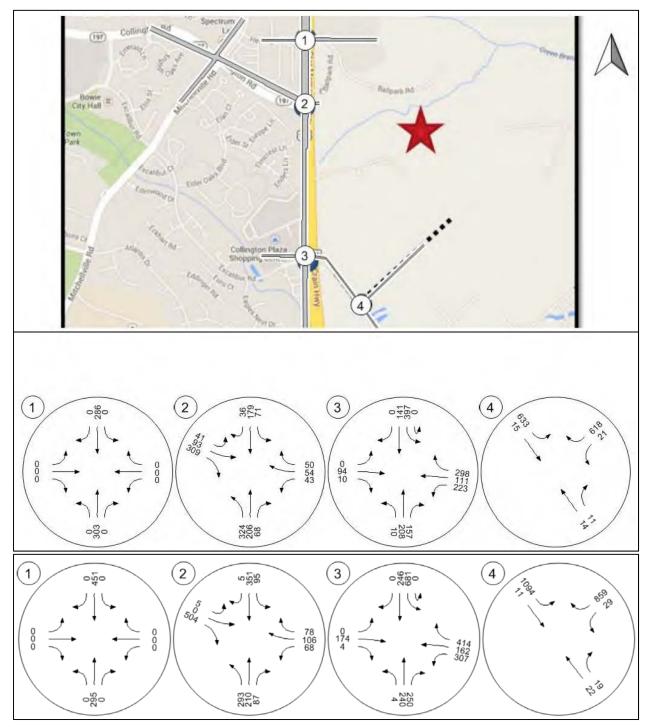
Figure 8. Future Volumes from Other Developments – PM Peak Hour, Saturday Peak Hour

Trip distribution and assignment were determined based on the expected land uses and surrounding roadway network. **Figure 8** shows the weekday PM peak hour and Saturday peak hour net new background vehicle trips at the study intersections.

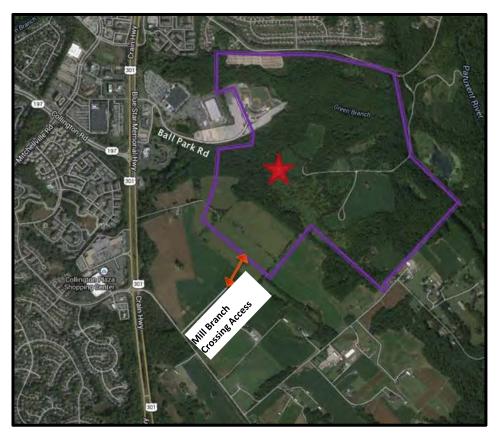
Figure 10. Site Access

The third alternative is providing site access from the south. As part of the planned Mill Branch Crossing, LLC development in the northeast quadrant of US 301 and Mill Branch Road, a 50-foot easement will be procured to provide access from Mill Branch Road. Currently, the sports complex expects to use the same roadway for its site access. To remain conservative, the analysis tested the transportation network with one single access point. **Figure 10** shows the site and the proposed access point.

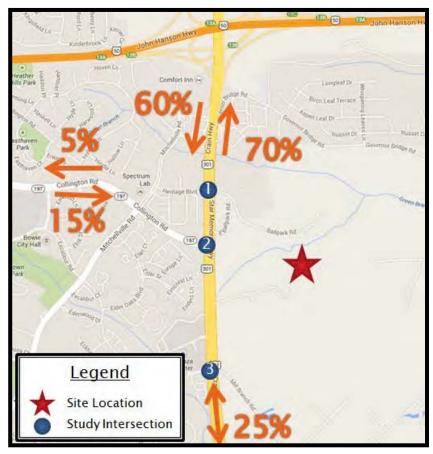
Figure 11. Trip Distribution and Assignment for Green Branch Sport Complex

As a regional park, traffic is expected to come from the surrounding area as well as from local trips. Trip distribution and assignment were determined based on the expected land uses and surrounding roadway network and are depicted in **Figure 11**. It accounts for trips from Baltimore and Annapolis, Maryland, using US Routes 3 and 50 from the north and east, and trips from the District of Columbia using US Route 50 and MD 197 from the west. Trips from southern Maryland and Virginia via US Route 301 are also accounted for. The site trips at the study intersections for the weekday PM and Saturday peak hours are shown in **Figure 12-14**.

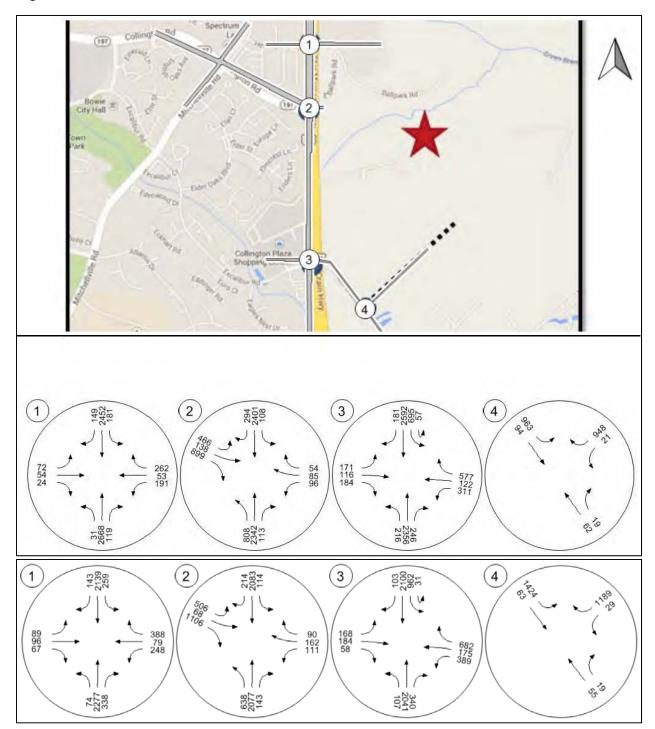
Figure 15. Future Volumes (12 Fields) – PM Peak Hour, Saturday Peak Hour

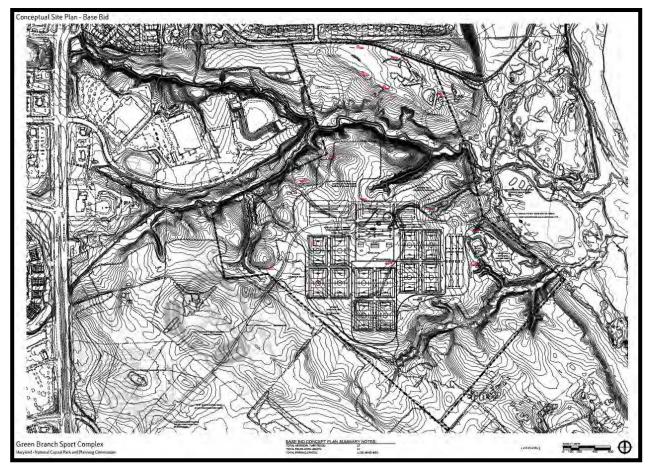
Figure 23. Conceptual Site Plan (Dated: 12-10-2013)

The site plan is provided as Figure 23.

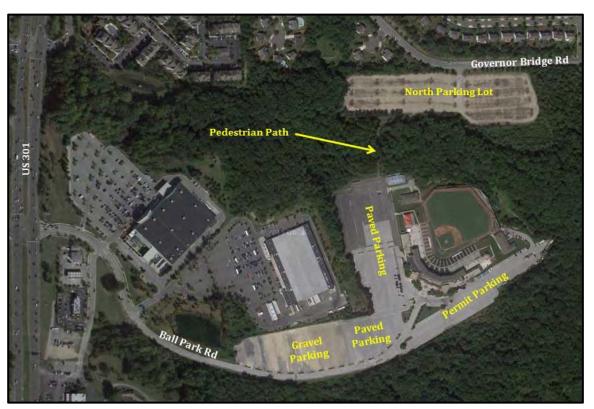
Figure 24. Existing Parking at Prince George's Stadium

A preliminary parking analysis was performed to forecast the future parking demand of the proposed multi-sports complex. Typically, lacrosse tournaments tend to produce continuous traffic, while soccer tournaments tend to see vehicles come in waves. Parking needs were calculated using data gathered from Premiere Lacrosse and engineering judgment. Along with the previous assumptions of 1.25 cars per player and 22 players per team, it was assumed that there would be approximately ten teams per field throughout a Saturday. This results in a total daily accumulation of 3,300 vehicles. If approximately 60 percent of the games are played in the morning and 40 percent are in the afternoon, approximately 2,000 parking spaces would be required for peak parking demand. These calculations do not include any shared parking reductions that could result from consolidating parking facilities with the neighboring sites, such as the Baysox Stadium, which could result in a decrease in the recommended number of parking spaces.

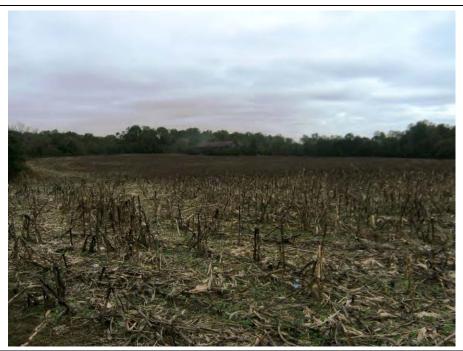
Photograph Number 1: General view of agriculture area that is located within the project study area, facing northeast. (Note: in the center of the photograph within the background is an existing barn structure).

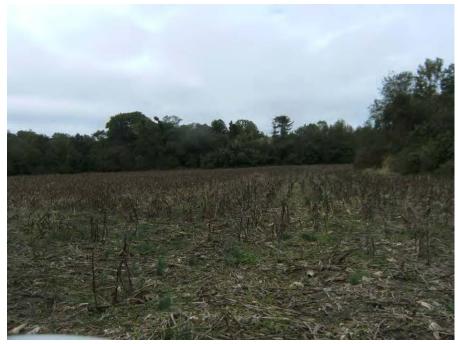
Photograph Number 2: General view of agriculture area that is located within the project study area, facing west. (Note: the forestland in the background).

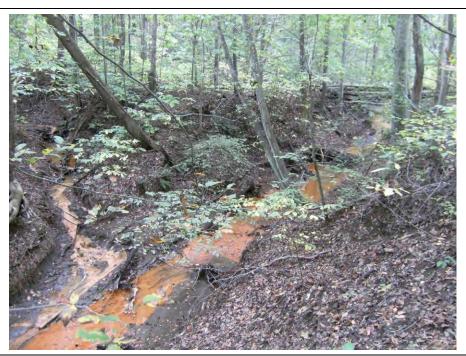
Photograph Number 5: Unnamed tributary to Green Branch located along the midwest portion of the project study area, facing southwest. (Note: Additional unnamed tributary that follows the left edge of the photograph).

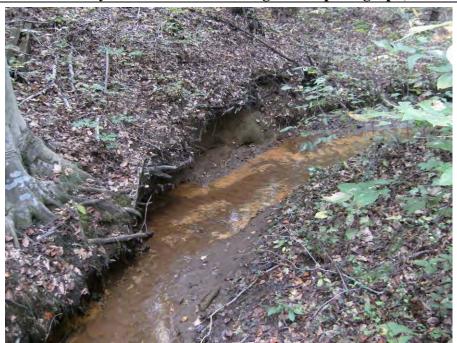
Photograph Number 6: Unnamed tributary to Green Branch located along the south portion of the project study area, facing northeast.

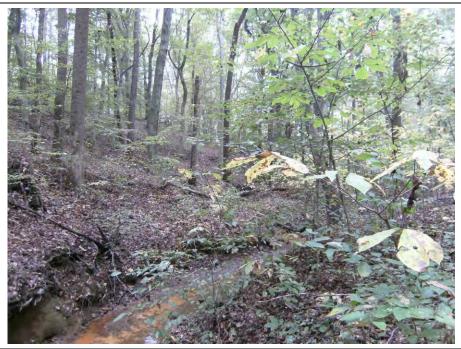
Photograph Number 7: Steep slopes along the unnamed tributary to Green Branch located along the south portion of the project study area, facing southwest.

Photograph Number 7 is a general view of the steep slopes that surround an unnamed tributary to Green Branch, located along the south portion of the project study area. Figure 5 (Soils and Topography Mapping, Appendix A) shows the 2-foot contours throughout the project study area.

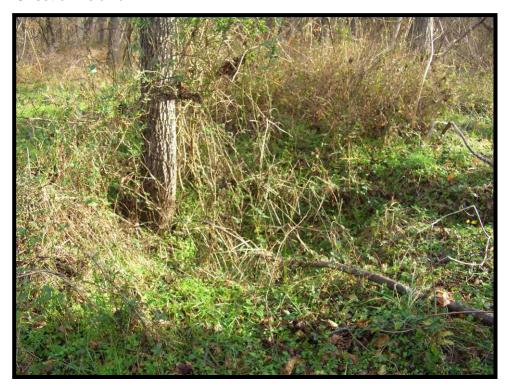
Figure 5. T. Watkins Site (18PR1028). Central Depression Identified as Feature 1 – a Brick-Lined Well Prior to Onset of Fieldwork.

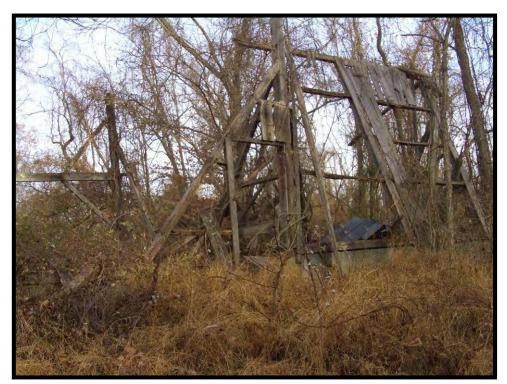
Figure 6. T. Watkins Site (18PR1028). View to the Southwest of Collapsing Barn on the Western Edge of the Site.

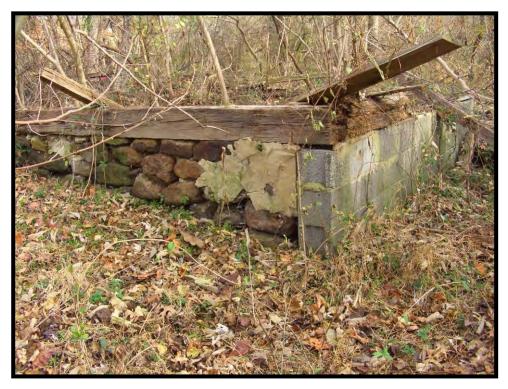
Figure 7. T. Watkins Site (18PR1028). View to the Northeast Showing Fieldstone Foundation of Outbuilding with Multiple Repairs.

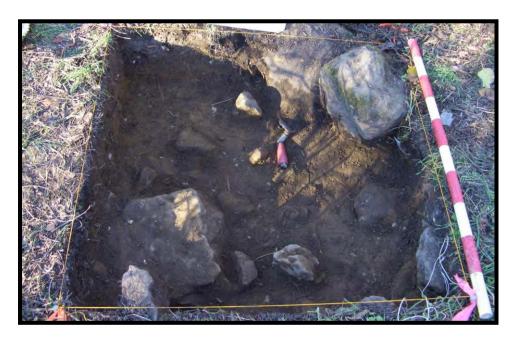
Figure 21. N1039 E1034. Fieldstones Visible on Surface and in Initial Layers.

Test Unit N1039 E1034 was placed to investigate a linear surface scatter of fieldstones that appeared to be a foundation located in the central portion of the site (Figure 20). The unit was placed such that two large fieldstones from the aforementioned scatter were visible at the surface in the northeast corner of the unit (Figure 21). Layer I consisted of a dark brown (10YR3/3) silty loam and extended to a maximum depth of 28 cm below surface (Figures 22 and 23). Numerous brick fragments were noted in association with the fieldstone. A total of 96 artifacts were recovered including large quantities of mortar, brick, and window glass. Kitchen

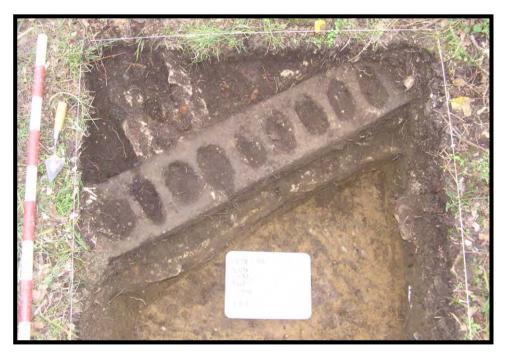
Figure 24. N1034 E1033. Feature 3 – Concrete Block on Mortar Foundation Wall. Plan View.

Test Unit N1037 E1031.5 was placed in an attempt to intercept Feature 3 which had been defined in Test Unit N1034 E1033 (see above) and, if possible, to excavate portions of both the interior and exterior soil matrices of the structure (Figure 20). Layer I was a very dark brown (10YR2/2) silty loam containing numerous, large fragments of concrete block, hand-made brick, and mortar (Figures 25 and 26). The large fragments were not collected, nor were the approximately 75 fragments of apparently recent window glass recovered from within this layer. At the base of the layer, at a depth of 32 cm below surface and underneath the larger chunks of concrete, the intact concrete block foundation previously designated as Feature 3 was identified

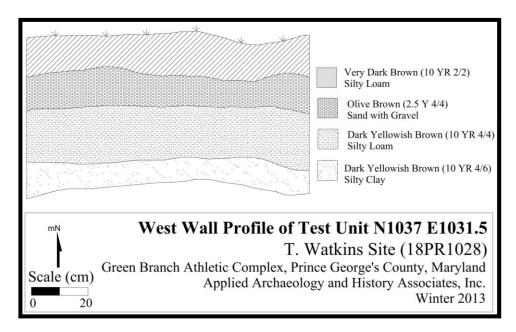
Figure 25. West Wall Profile of Test Unit N1037 E1031.5.

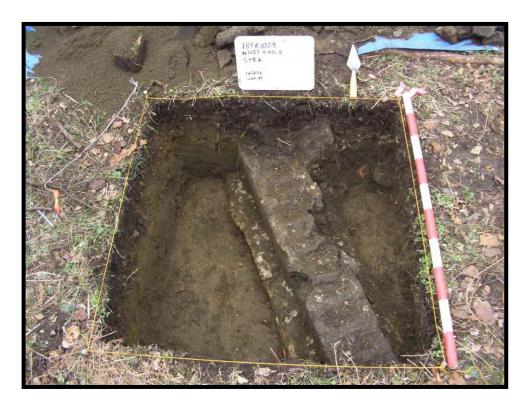
Figure 27. N1037 E1031.5. Feature 3 – Concrete Block on Mortar Wall. Interior on Right. Exterior on Left.

running southeast to northwest approximately halfway across the unit (Figure 27). A total of 58 artifacts was recovered including nails and asphalt roofing tile fragments, as well as 19th-century ironstone, bottle glass, and a sardine can key. Other artifacts included three buttons, a clip-on earring with fake diamonds, a red butane lighter with pink flowers, and a blue plastic alpaca toy.

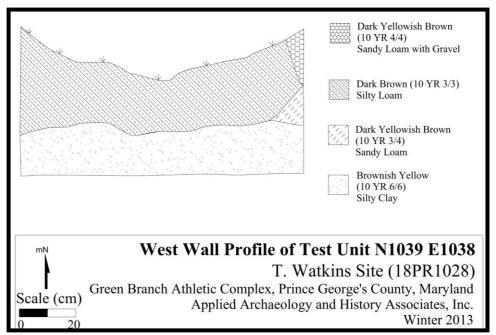
Figure 28. West Wall Profile of Test Unit N1039 E1038.

Layer II consisted of a dark yellowish brown silt sand densely packed with gravel that extended over much of the eastern portion of the unit (Figures 28 and 29). This layer extended to a depth of 25 cm on the east side. The western portion of the unit within the depression continued as a dark brown (10YR3/3) silt loam notably similar to Layer I to a depth of 32 cm; this was probably a continuation of Layer I lacking the decomposed organic elements that caused that layer to appear so dark. A total of 108 artifacts was recovered from this layer, again, consisting primarily of window glass, nails, and bottle glass. Two sherds of redware and one sherd of 20th-century porcelain in a banded design were also recovered.

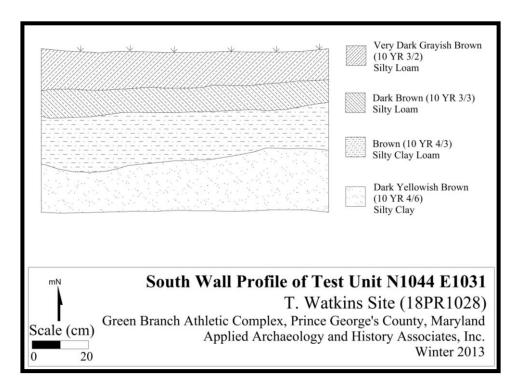
Figure 30. South Wall Profile of Test Unit N1044 E1031.

The brick and mortar continued into Layer II, which consisted of a dark brown (10YR3/3) silt loam (Figures 30 and 31). The fieldstone concentration was found to extend to the base of Layer II, which ended at a depth of 36 cm below surface. Artifact recovered included

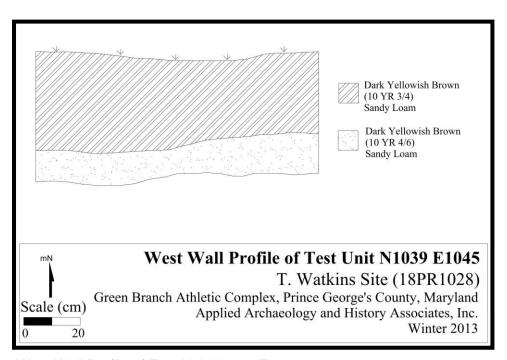
Figure 32. West Wall Profile of Test Unit N1039 E1045.

Layer II was a dark yellowish brown (10YR4/6) silt sand subsoil containing no artifacts and excavated to a depth of 50 cm below surface (Figures 32 and 33). This was one of only two units that produced a single soil stratum over subsoil (the other was N1025 E1018 in the western portion of the site). This is, perhaps, indicative of the use of this area as a yard surface or, perhaps, the disuse of this area in general through the 20th century. The artifact assemblage definitely indicates as relatively early period of accumulation.

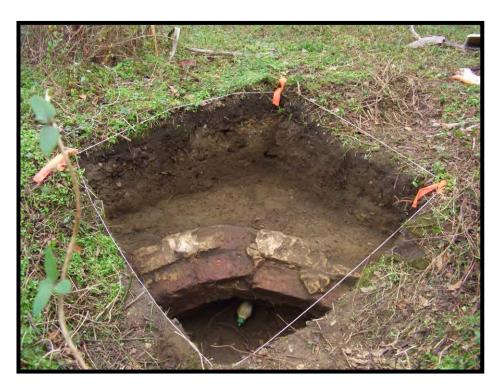
Figure 34. N1034 E1023. Feature 1. Brick-Lined Well Showing 20th-Century Plastic Bottle Beneath Displaced Lining.

<u>Unit N1034 E1023</u> was placed to investigate a large depression near the northern edge of the site that was identified as a possible shaft feature (Figure 20). The unit was situated on the southeastern side of the depression and extended approximately 50 cm into it (Figure 34). As a result, the southeastern corner of the unit is substantially higher than the others,

Test Unit N1034 E1023 was placed to investigate a potential well feature. Excavation did, indeed, confirm the presence of a mortared brick-lined well. It also indicated that, at least in its upper portion the well had been affected by heavy equipment with a portion of the lining pushed in over the fill deposits. The fill deposits were excavated to approximately a meter below

the surface and, while some early artifacts were recovered – including a clay pipebowl fragment, pearlware, creamware, and dark olive green bottle glass – the majority of the fill deposits included extremely recent artifacts such as plastic dishwashing soap bottles, plastic tarps, plastic blister packaging, and Styrofoam. These materials were found in varying quantities in all layers excavated and, if anything, were becoming more prevalent with depth. This is not to say that older fill deposits might be recovered from deeper contexts but excavations possible within this Phase II evaluation resulted only in the interpretation of the feature being filled at or about the time of the acquisition of the property by the WSSC.

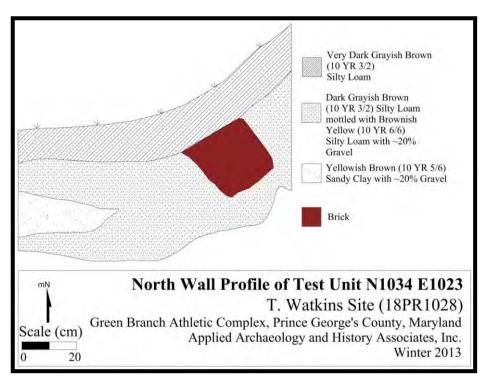
Figure 36. North Wall Profile of Test Unit N1034 E1023.

Layer III consisted of a clay lens in the southwest corner of the unit, colored strong brown (7.5YR5/6) and mottled with a dark grayish brown (10YR4/2) sandy loam. The mottling was indicative of a disturbance like a rodent burrow, which was determined to be the likely interpretation of this layer after several probable rodent bones were recovered from it. This layer was only present in the southwest corner, and extended to a depth of 36 cm below datum. A total of 17 artifacts was recovered from this layer and included a sherd of creamware as well as a sherd of 19th-century ironstone. In addition a fragment of free blown olive green bottle glass was recovered.

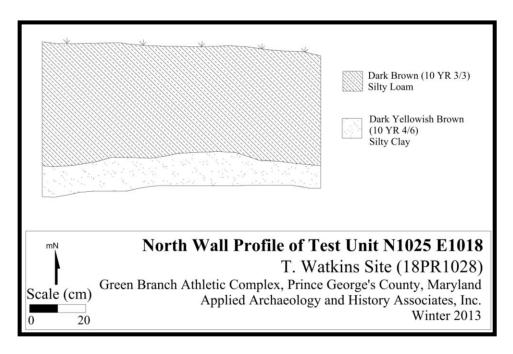
Figure 37. North Wall Profile of Test Unit N1025 E1018.

<u>Test Unit N1025 E1018</u> was placed midway between the fieldstone foundation and the collapsed buildings (Figure 20). Layer I was a dark brown (10YR3/3) silt loam, with a very dark

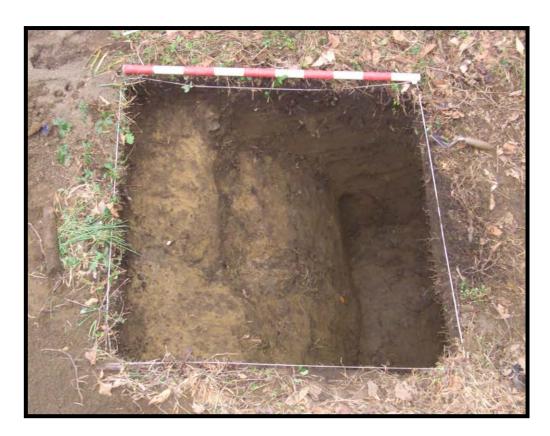
Figure 39. N 1016 E1004. Feature 2. View to the East Showing Large Pit Feature Partially Excavated. Maximum Depth of Excavation – 140 cm Below Surface.

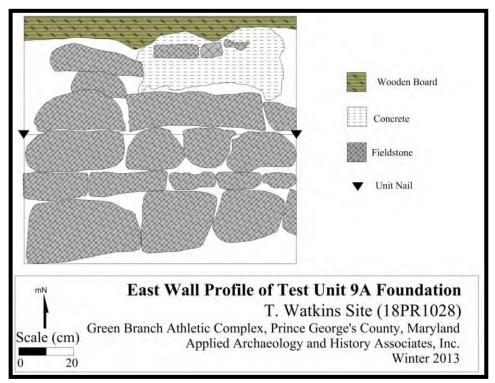
Figure 41. East Wall Profile of Test Unit 9A - Foundation.

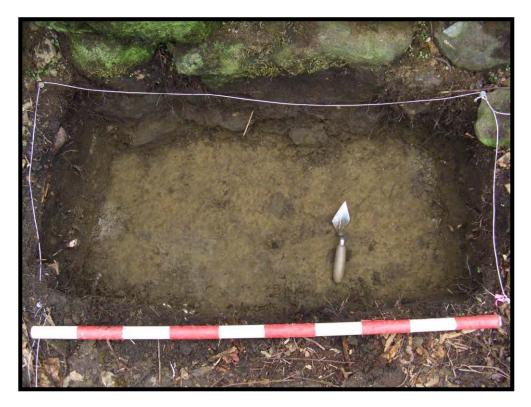
Figure 42. Unit 9B. Base of Layer II Showing Foundation Wall of Southern Outbuilding with Subsoil. No Builder's Trench was Identified.

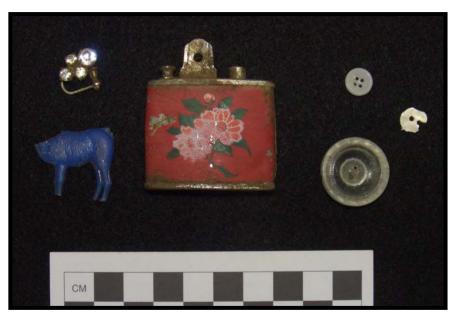
Figure 43. Artifacts Recovered from Test Unit N1037 E1031.5. Left to Right: Earring, Plastic Alpaca, Butane Lighter, Buttons.

Test Unit N1037 E1031.5 revealed an additional segment of the concrete block foundation wall. Layer 1 produced quantities of architectural materials along with a single sherd of 19th-century ironstone, a tablespoon, four buttons, a sardine can key, a lady's butane lighter, an earring, and a plastic toy alpaca (Figure 43). In the strata below Layer 1, artifacts recovered from the east (interior) side of the wall included large quantities of architectural material along with canning jar fragments. A single fragment of dark olive green glass as was recovered. Artifacts recovered from the west (exterior) side of the wall included a fewer architectural materials. A fragment of white salt-glazed stoneware and English Brown stoneware were recovered along with a pen nib. The context for these artifacts was interpreted to be a former yard surface associated with the structure. As the 20th-century material does not extend into this stratum it appears to indicate that these artifacts represent an intact archaeological deposit dating to the late 18th through 19th century.

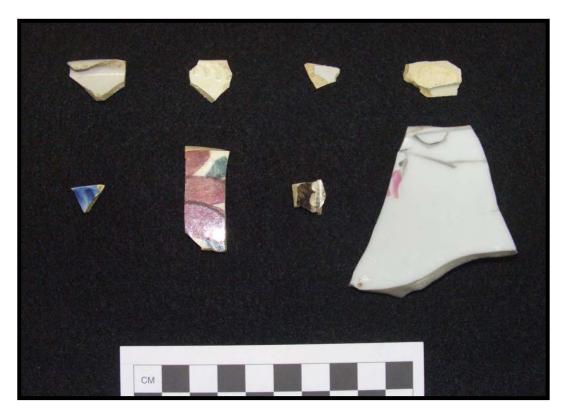
Figure 44. Ceramics Recovered from the T. Watkins Site (18PR1028). Top Row, Left to Right: White Salt-Glazed Stoneware, Feather-Edged Creamware, Tin-Enameled Earthenware, and Undecorated Pearlware. Bottom Row, Left to Right: Edge-Decorated Pearlware, Polychrome Hand-Painted Whiteware, Black Transfer-Printed Ironstone, 20th-Century Porcelain.

earthenware) through the 20th century (Figure 44). Table 4 presents a tabulation of the various ceramic types and their dates of manufacture. The most prevalent ceramic was 19th century ironstone with 60 sherds recovered uniformly across the site. A total of 24 sherds of pearlware, with manufacture dates ranging from 1780 to 1830, were recovered. Creamware (1762 – 1791) was represented by 12 sherds and white salt-glazed stoneware (1715 – 1775) was represented by seven sherds. A calculation of the mean ceramic date produced a date of 1828.19.

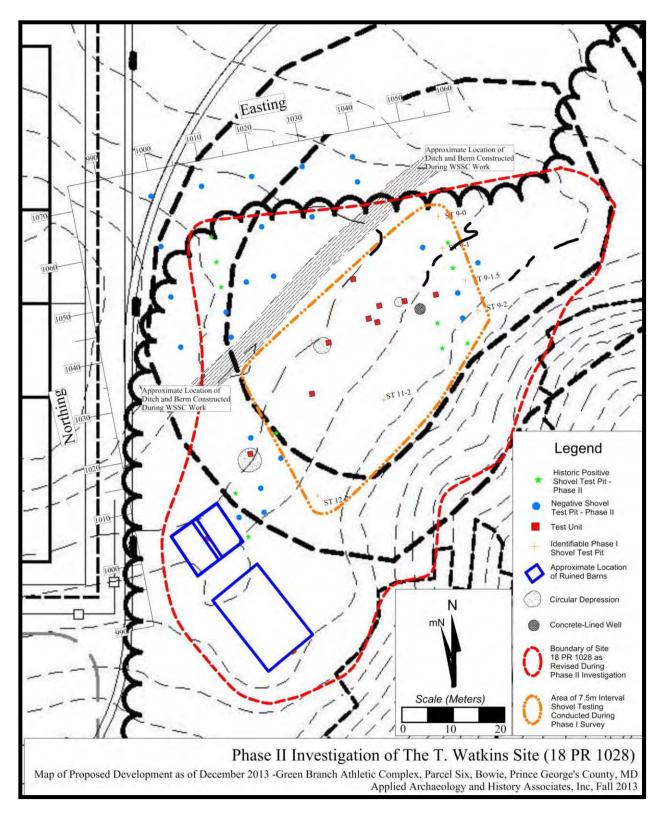
Figure 45. Phase II Investigation of the T. Watkins Site (18PR1028) over Map of Proposed Development as of December 2013.
